# MORPHOLOGY CHANGES TO CARMEL RIVER STATE BEACH IN RELATION TO WAVES AND RIVER DISCHARGE

## **THESIS**

June 2019

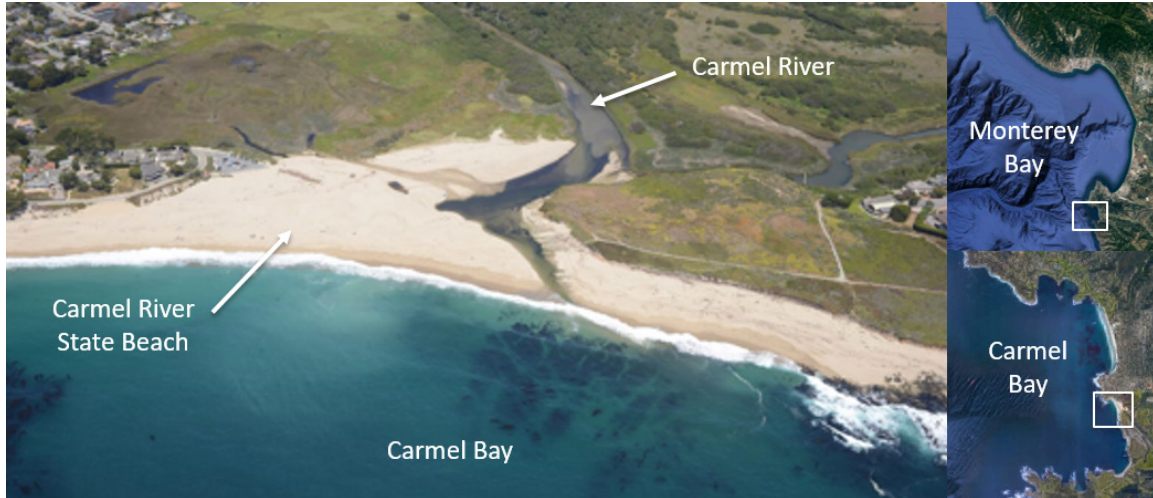
Figure 1. Carmel River State Beach location

This study examines the morphological evolution of Carmel River, an ephemeral river located in central California, over two contrasting winter seasons. Separated from Carmel Bay by the Carmel River State Beach (CRSB) (Figure 1), the Carmel River seasonally breaches into the bay most years, causing topographic changes to the shape of the beach based on the initial location of the breach and the meanderings of the outlet after breaching (Kraus et al. 2002; Kraus and Munger 2008; Scooler 2017; Young 2018; Orescanin and Scooler 2018). Using aerial photography and the implementation of SfM

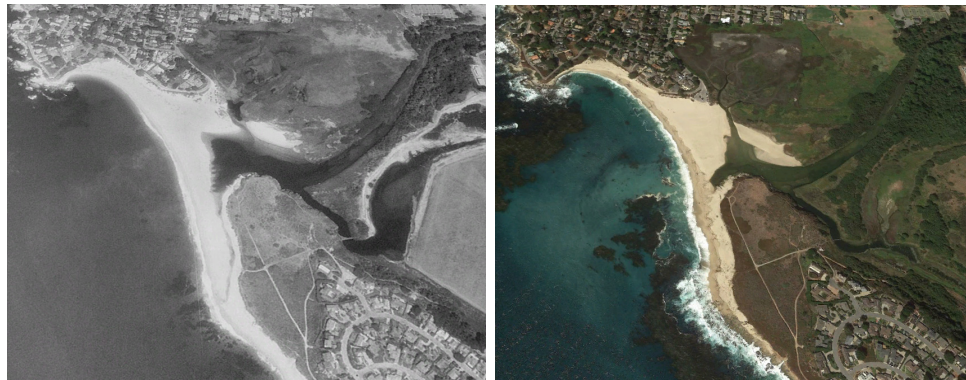
Figure 2. Historical comparison of Carmel River State Beach extent and shape in 1998 (left) and 2018 (right)

These images were generated using Google Earth.

Owing to the long-term (decadal) stability at Carmel River State Beach (Figure 2), it is possible to study short-term breaching events and migrations over many years without the need to consider longer scale migrations. Traditionally, beaches tend to aggregate or erode through sediment transport and migration. However, as seen in Figure 2, this beach has historically maintained a similar width and length extent. The breaching by the Carmel River occasionally results in migration of the river outlet on the scale of hundreds of meters, effectively altering the beach profile.

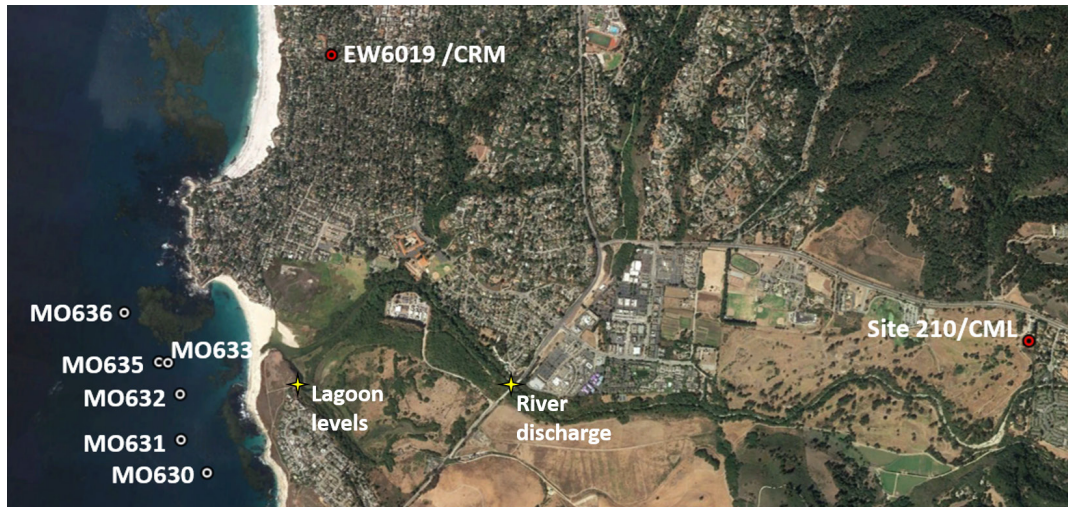
Figure 5. Data site locations

The stations plotted measure lagoon level, river discharge, and precipitation rates. The CDIP MOP sites are located along the 15-meter isobaths at Carmel River State Beach.

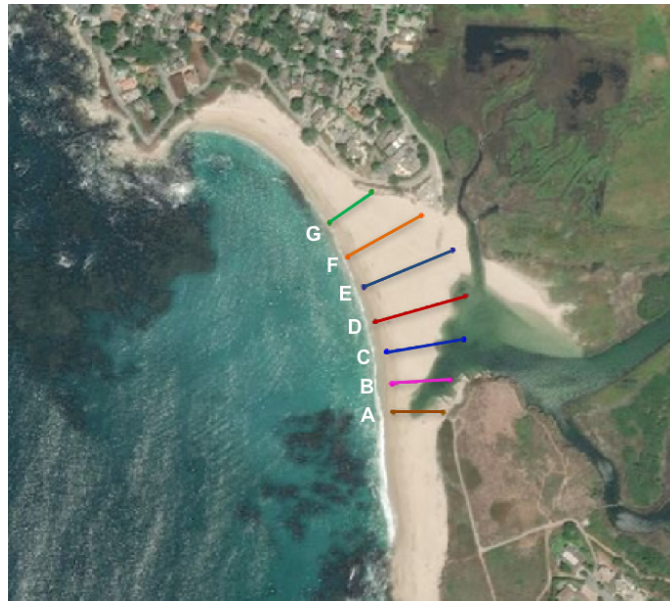
Figure 6. Carmel River State Beach cross-section locations

Seven shore-normal beach cross-sections were positioned across the beach to evaluate changes in beach elevation over time (Figure 6). These cross-sections were determined for each survey date, exported from SMS, analyzed and compared to other survey dates. Additionally, the differences between specific elevation maps were analyzed to observe the overall change in sediment movement, accretion or erosion, over

Analysis of the photogrammetry surveys allowed for seasonal trends in morphology at CRSB to be established. Using the cross sections described in Figure 6, cross-shore elevation changes could be observed throughout each season. These results are displayed in Figure 8 and Figure 9.
